Technical Report CHL-97-25  
August 1997

# **Model Study of the Confluence of San Juan Creek and Trabuco Creek, Orange County, California**

## **Hydraulic Model Investigation**

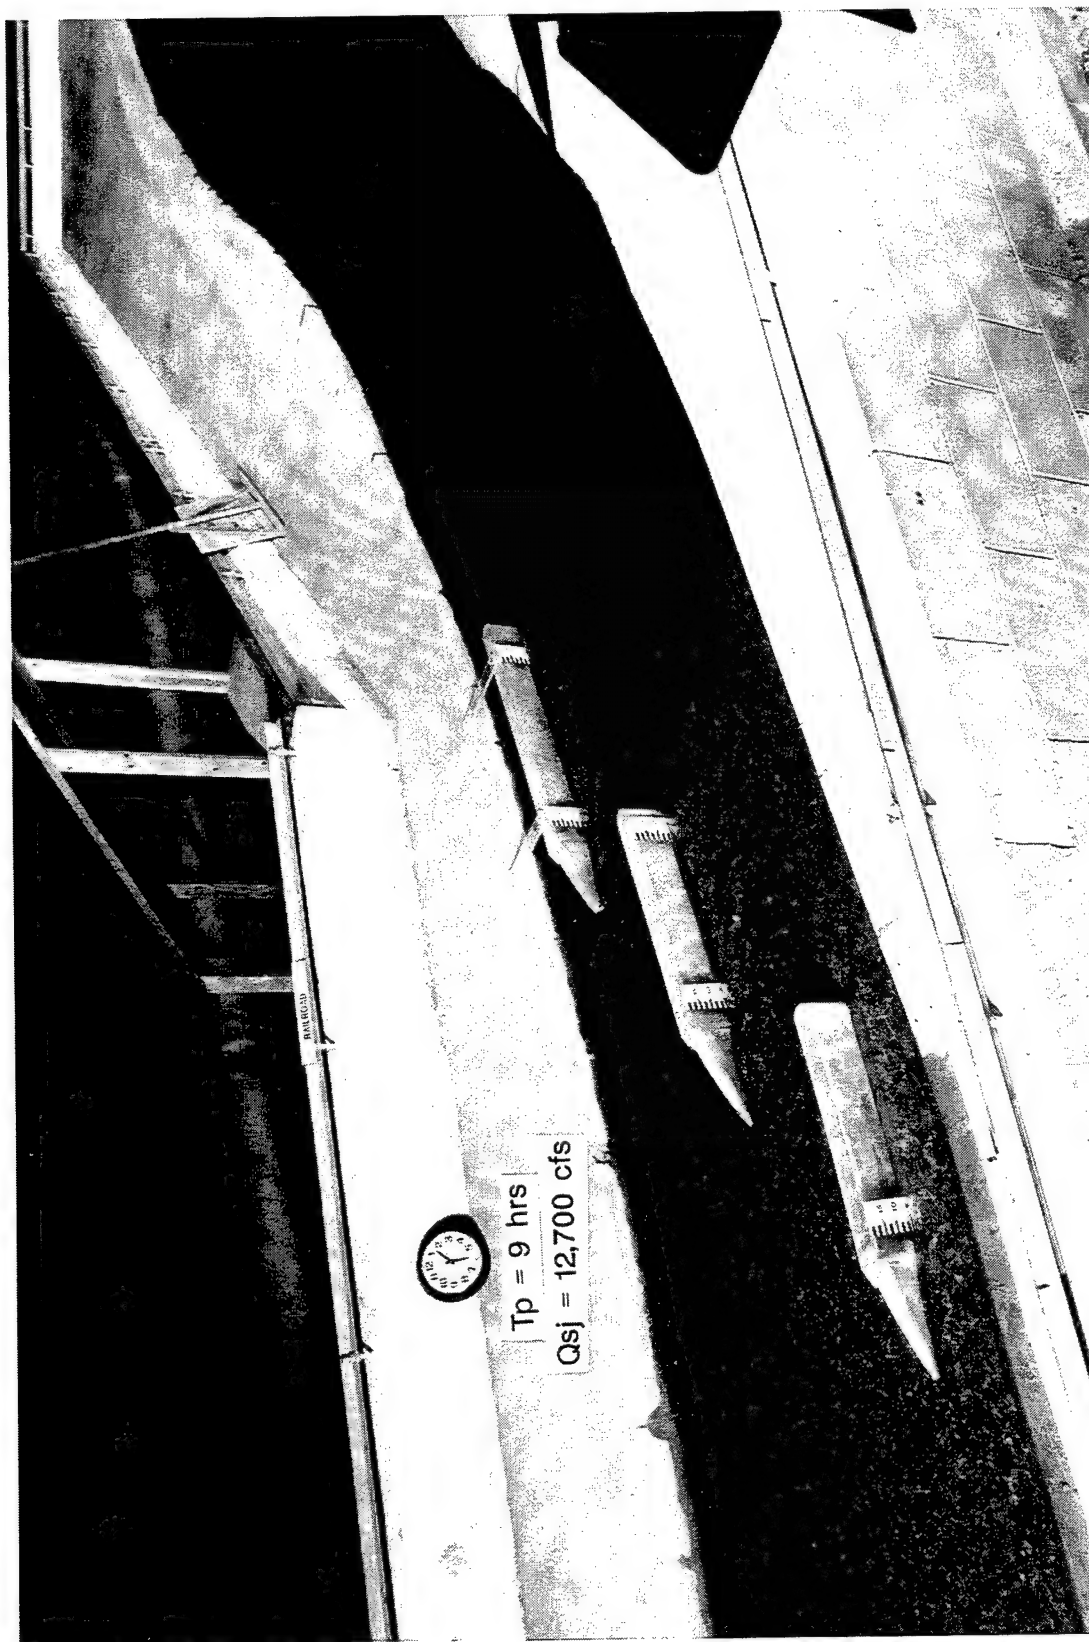
Photo 18. San Juan Creek, type 7 design, flow conditions in the vicinity of the railroad bridge piers during 24-hour storm hydrograph, side view, prototype time 9 hours,  $Q_{sj}$  12,700 cfs (356 cu m/sec)

Before the gravel-bed experiment was run, the model was flooded from the upstream end. Once the model was completely saturated, the desired discharge was set. The discharges and duration of the 24-hr storm runoff hydrograph for both San Juan and Trabuco Creeks were simulated. The actual hydrographs and the simulated hydrographs for both creeks are provided in Plate 50. For the duration of the experiment, the flow remained uniform with occasional standing waves observed. The flow conditions observed around the railroad bridge piers in San Juan Creek at 1- and 2-hr intervals in the hydrograph are shown in Photos 14-33. Flow conditions observed at the confluence are shown in Photos 34-53.

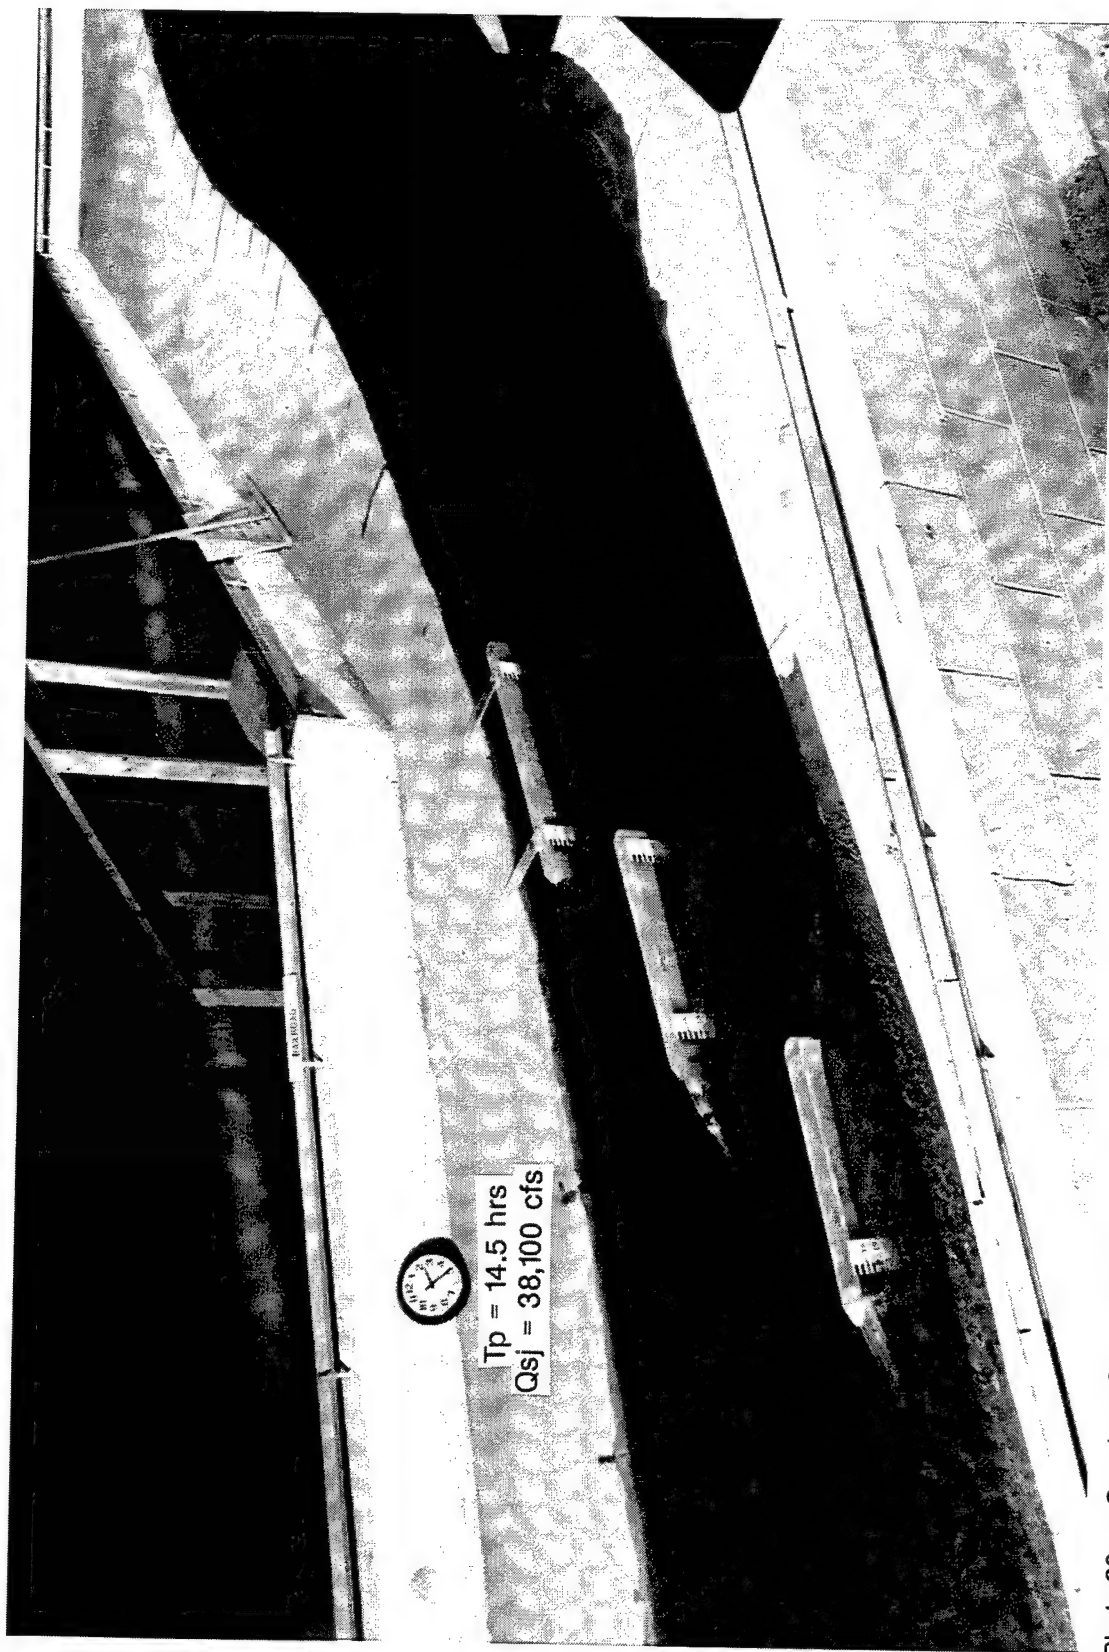
Photo 23. San Juan Creek, type 7 design, flow conditions in the vicinity of the railroad bridge piers during 24-hour storm hydrograph, side view, prototype time 14.5 hours,  $Q_{sj}$  38,100 cfs (1,067 cu m/sec)

At the onset of the experiment, no sediment transport was detected. It was not until 6 hr into the hydrograph ( $Q_r$  3,700 cfs (104 cu m/sec)) that sediment movement in Trabuco Creek was first noticed. In San Juan Creek, the sediment did not start moving until 14 hr into the hydrograph ( $Q_{sj}$  38,100 cfs (1,067 cu m/sec)) (Photo 23). At 15 hr, the combined flow of San Juan and Trabuco Creek ( $Q_{total}$  61,700 cfs (1,747 cu m/sec)) overtopped the right embankment at sta 134+00 and the left embankment downstream of the confluence at sta 126+00 (Photos 24-26 and Photos 44-46). At 17 hr, the combined flow ( $Q_{total}$  46,700 cfs (1,308 cu m/sec)) was again contained within its banks (Photos 27 and 47). The increase in roughness from a finished concrete channel (model Manning's  $n = 0.012$ ; prototype Manning's  $n = 0.022$ ) to a gravel bottom channel (model Manning's  $n = 0.021$ ; prototype Manning's  $n = 0.038$ ) decreased the average channel velocity and increased the flow depth enough to overtop its banks. (Manning's roughness coefficients,  $n$ , were obtained from Chow<sup>1</sup>).

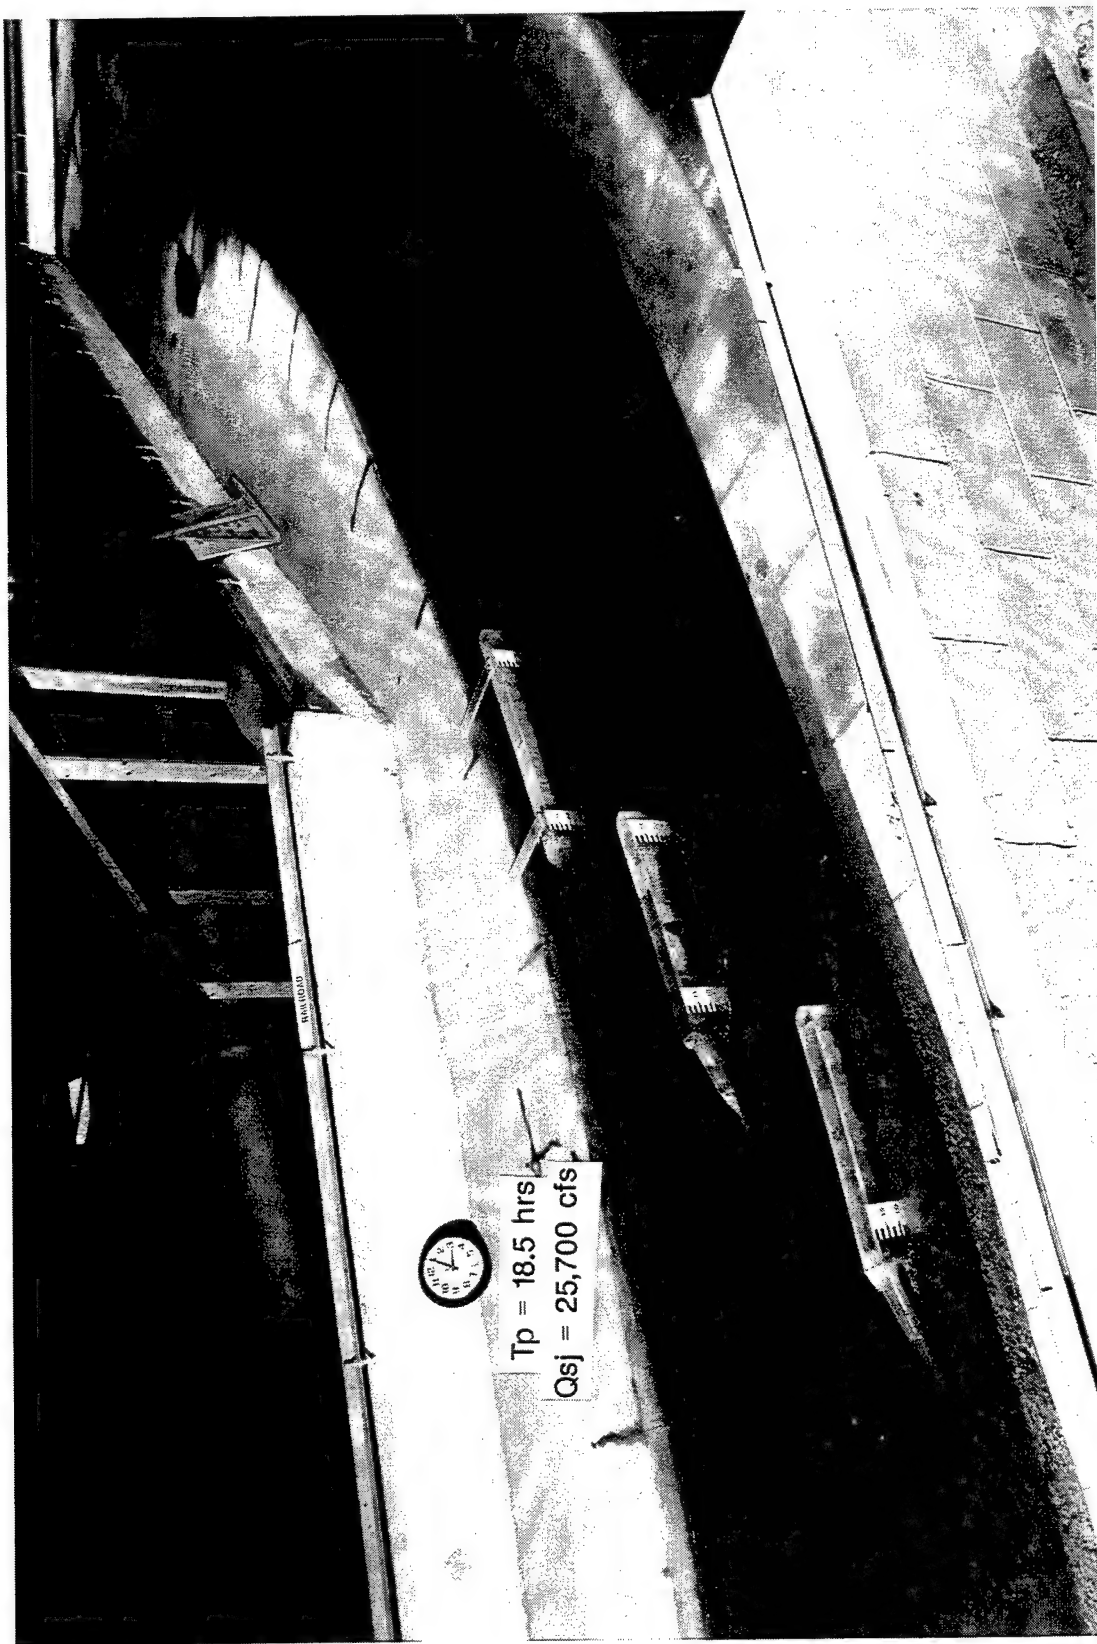
Photo 28. San Juan Creek, type 7 design, flow conditions in the vicinity of the railroad bridge piers during 24-hour storm hydrograph, side view, prototype time 18.5 hours,  $Q_{sj}$  25,700 cfs (720 cu m/sec)

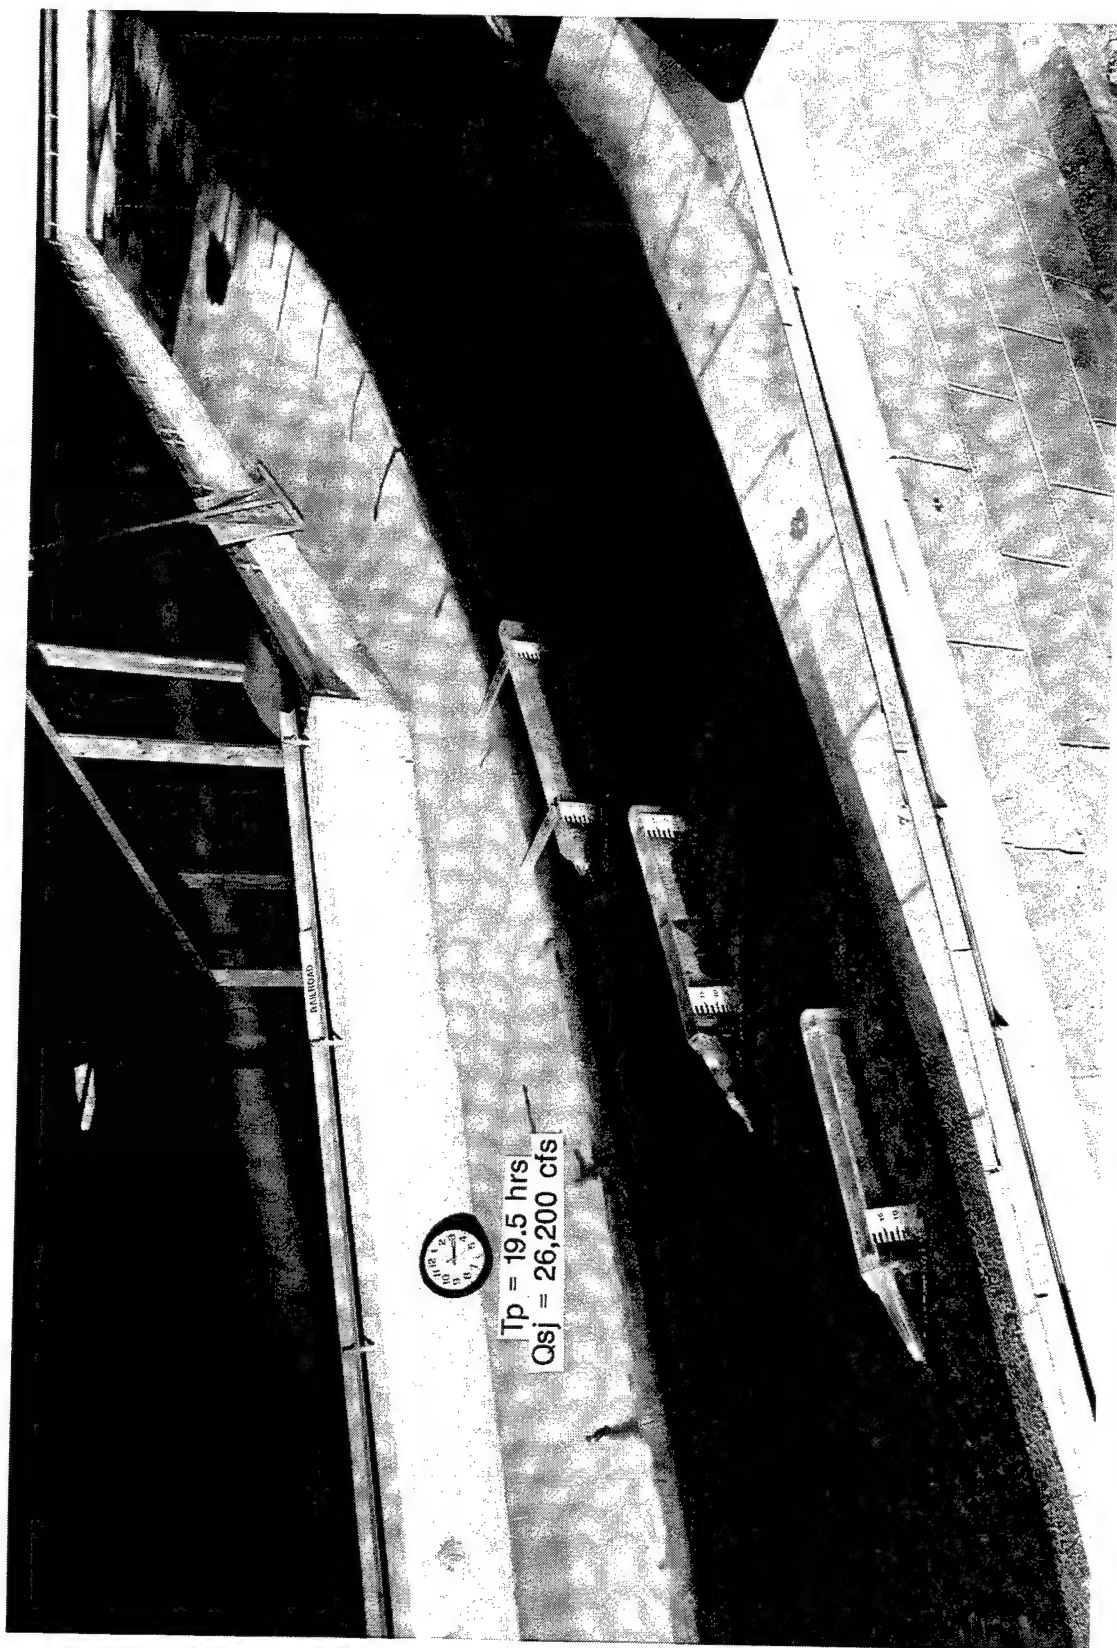
Photo 29. San Juan Creek, type 7 design, flow conditions in the vicinity of the railroad bridge piers during 24-hour storm hydrograph, side view, prototype time 19.5 hours,  $Q_{sj}$  26,200 cfs (734 cu m/sec)

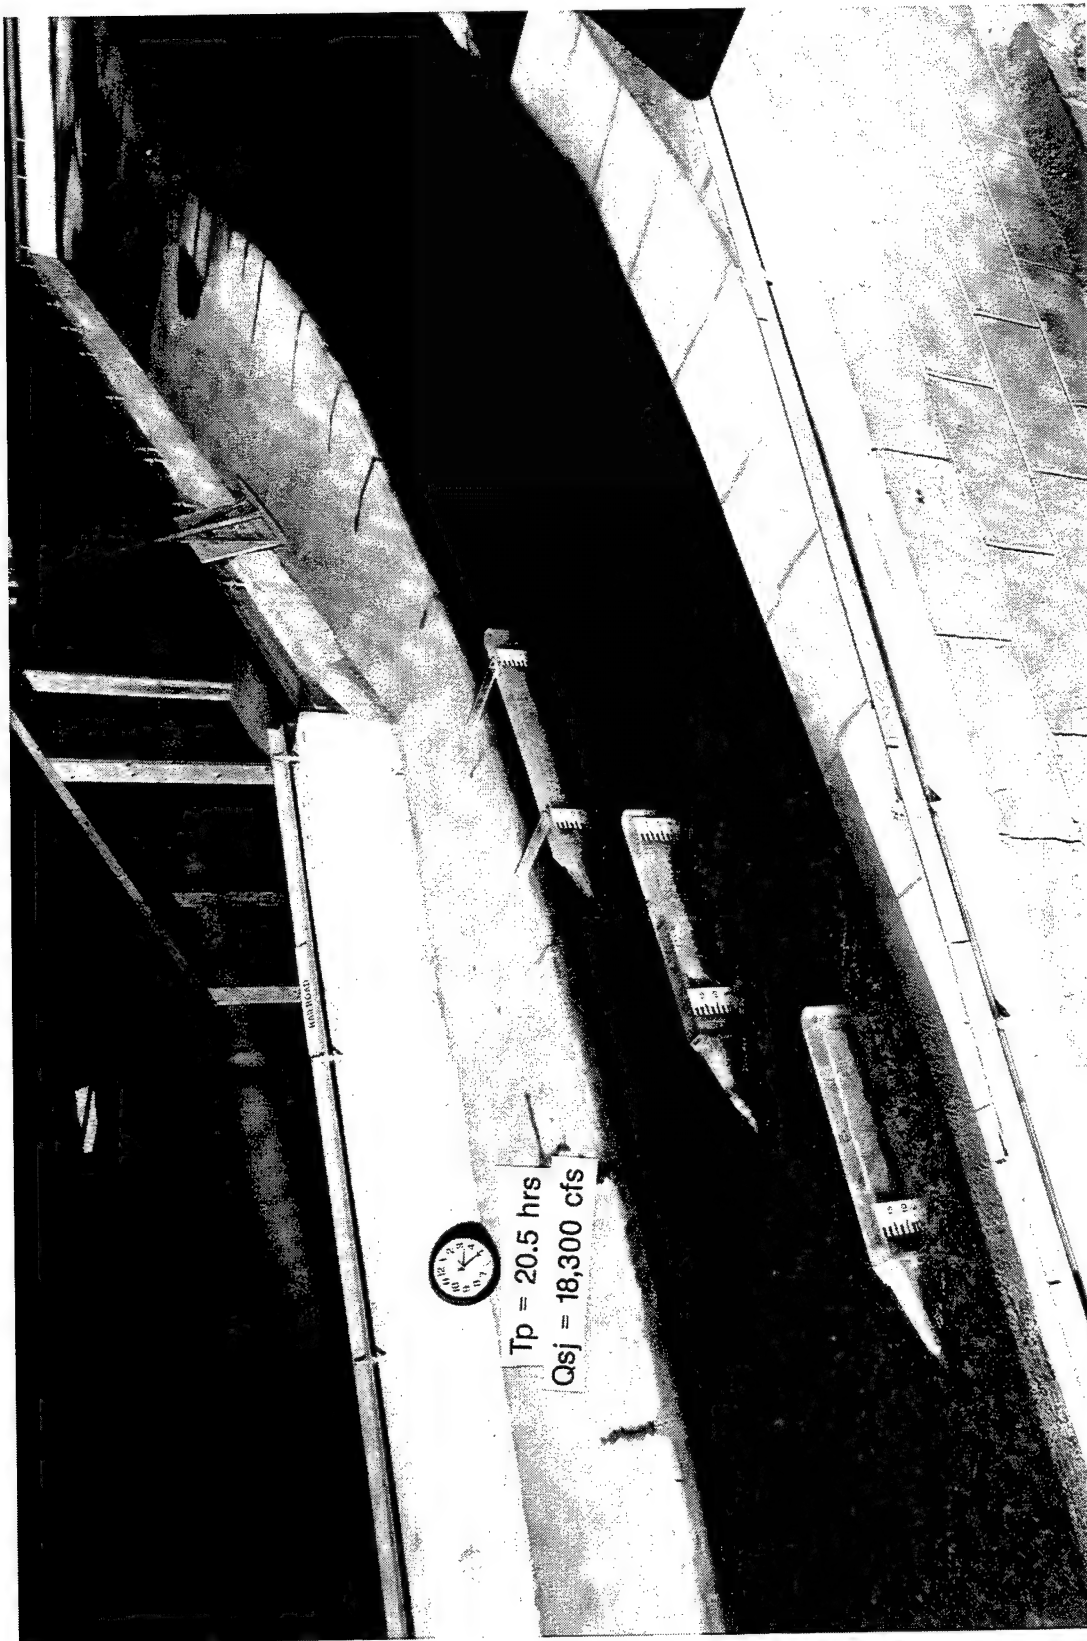
Photo 30. San Juan Creek, type 7 design, flow conditions in the vicinity of the railroad bridge piers during 24-hour storm hydrograph, side view, prototype time 20.5 hours,  $Q_{sj}$  18,300 cfs (512 cu m/sec)

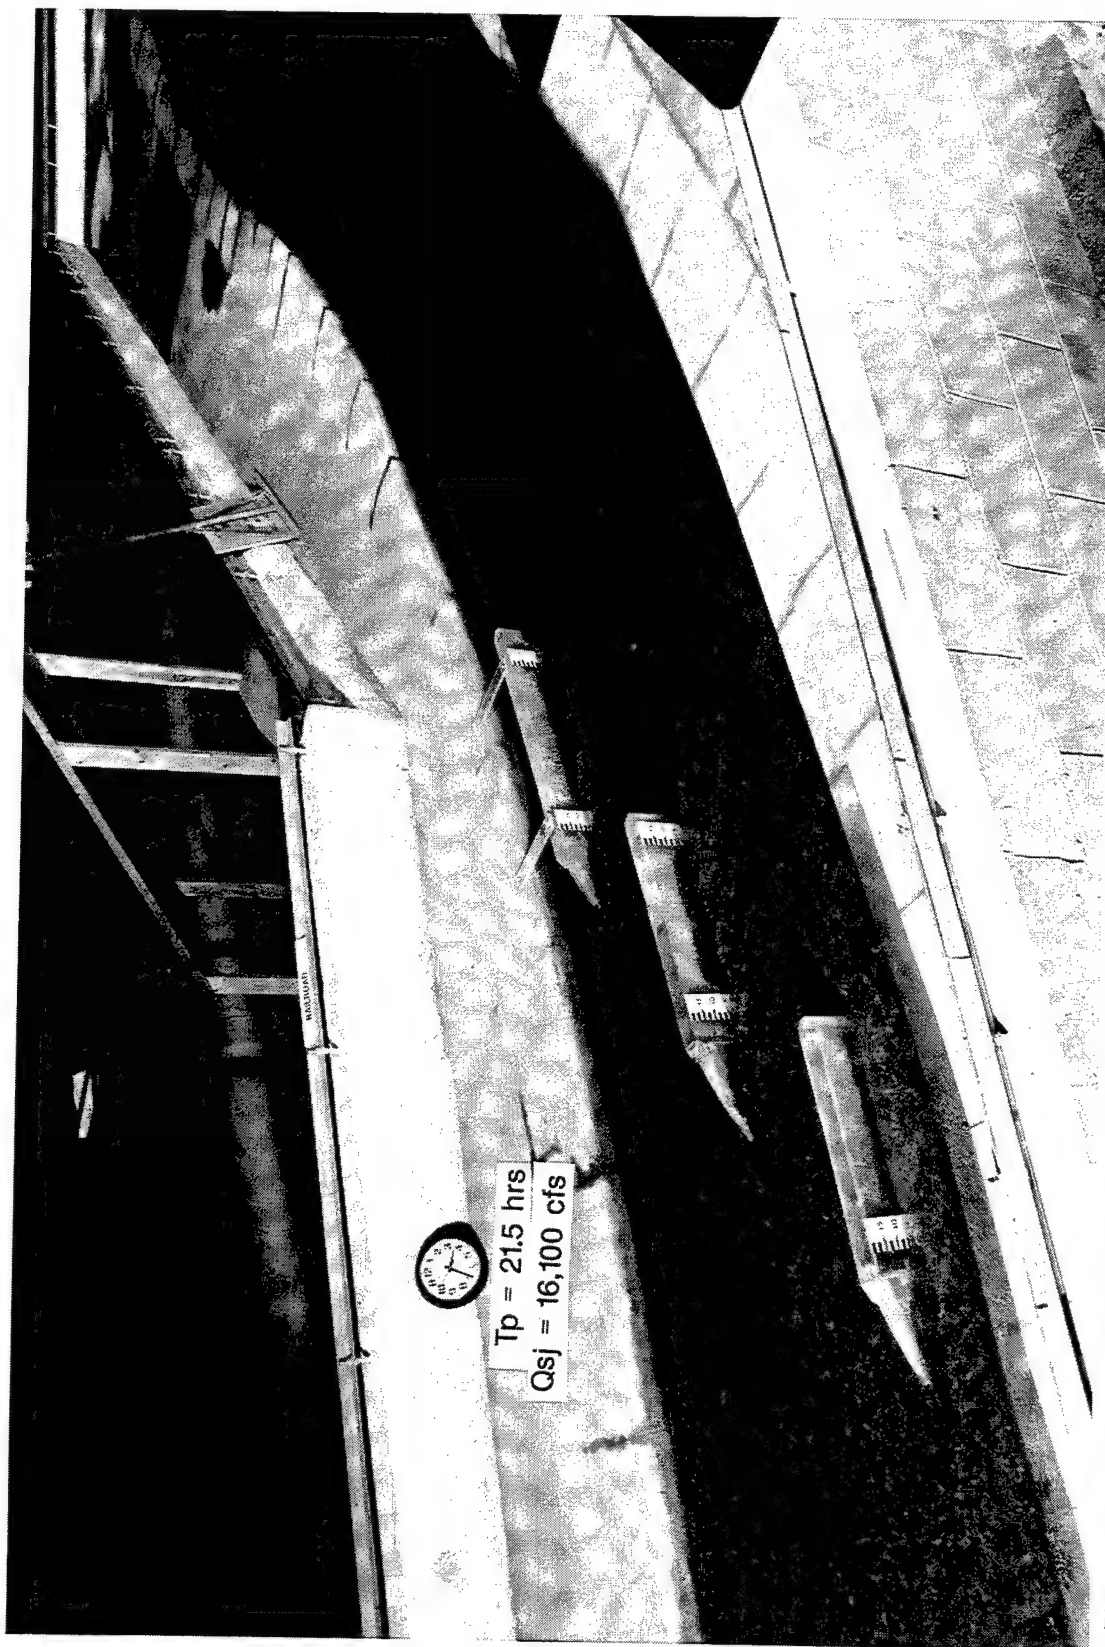
Photo 31. San Juan Creek, type 7 design, flow conditions in the vicinity of the railroad bridge piers during 24-hour storm hydrograph, side view, prototype time 21.5 hours,  $Q_{sj}$  16,100 cfs (451 cu m/sec)

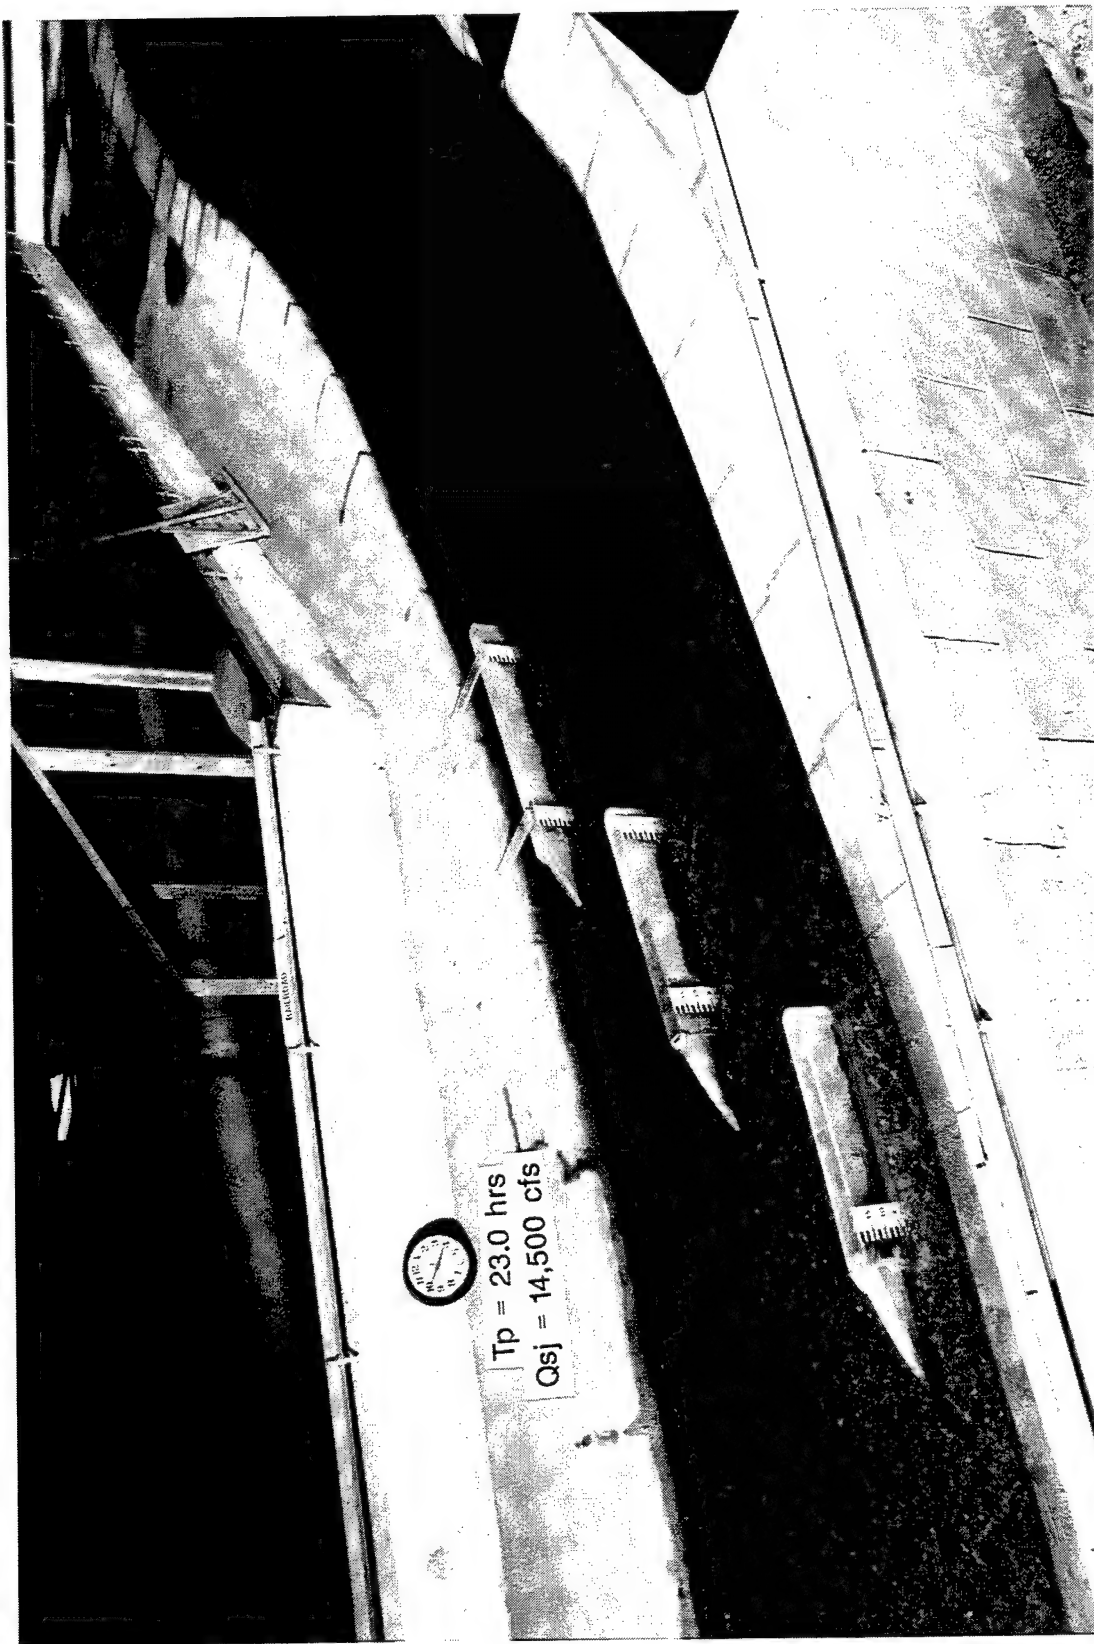
Photo 32. San Juan Creek, type 7 design, flow conditions in the vicinity of the railroad bridge piers during 24-hour storm hydrograph, side view, prototype time 23 hours,  $Q_{sj}$  14,500 cfs (406 cu m/sec)

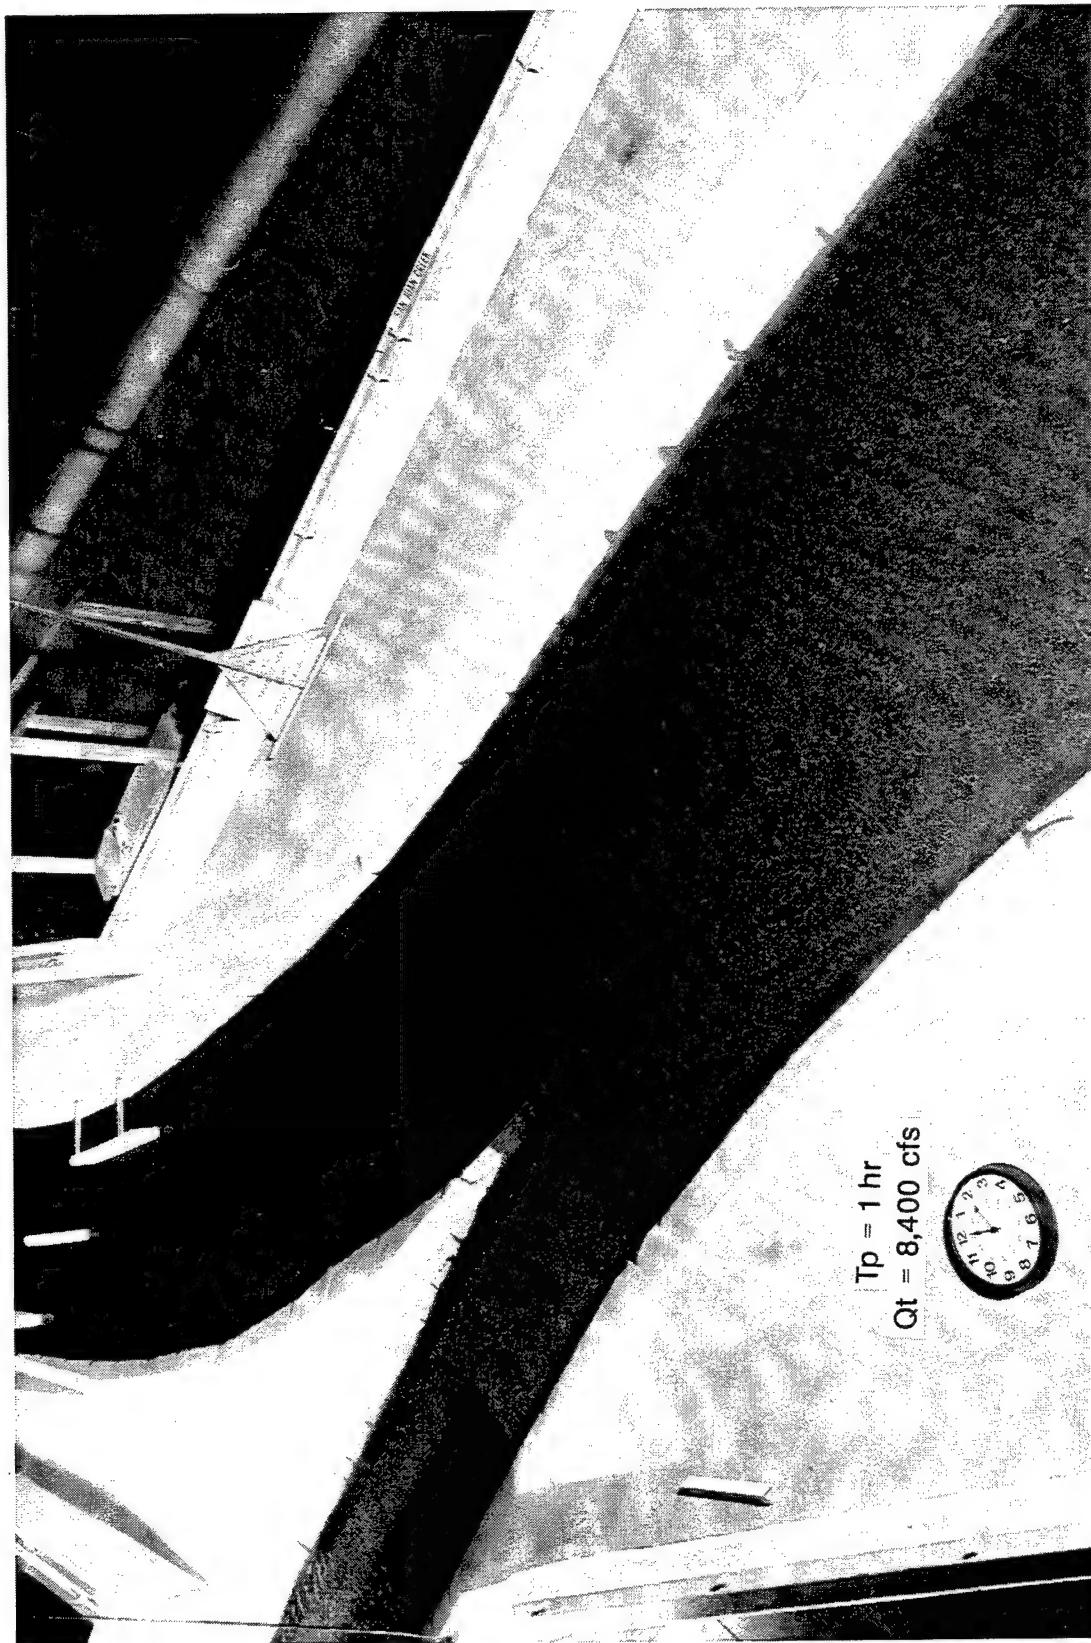
Photo 34. San Juan Creek, type 7 design, flow conditions at confluence with Trabuco Creek during 24-hour storm hydrograph, looking upstream, prototype time 1 hour,  $Q_{sj}$  8,400 cfs (235 cu m/sec)

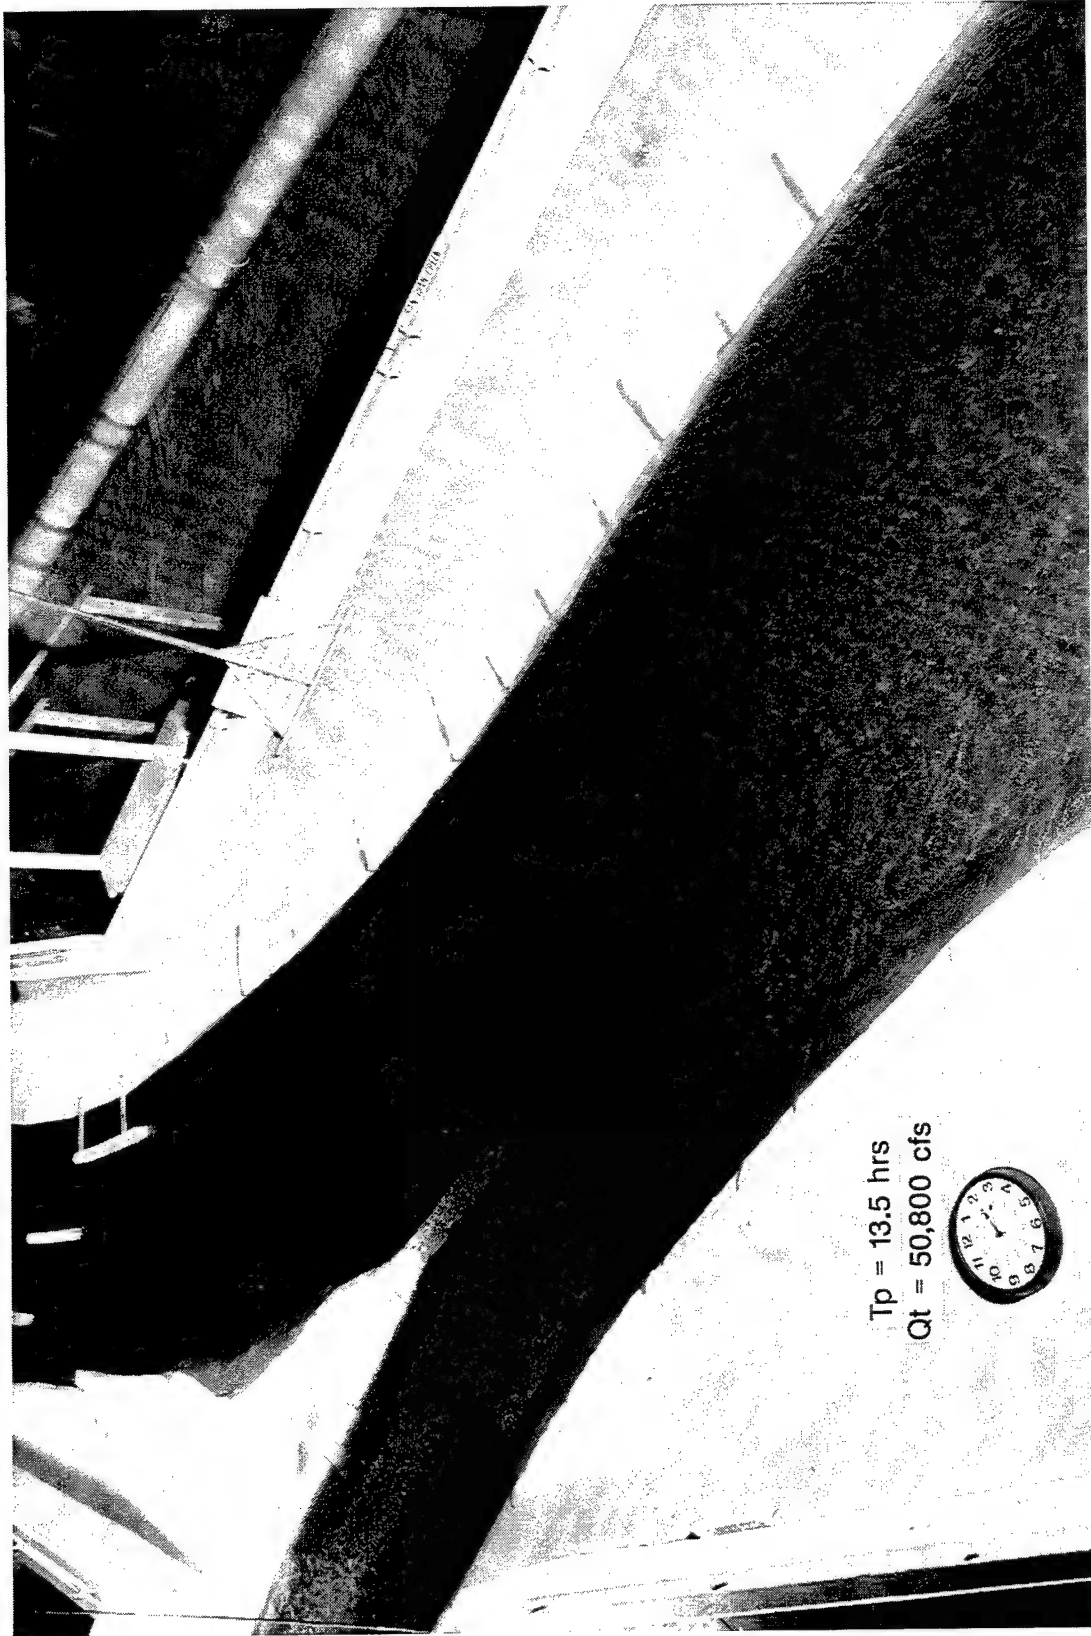
$T_p = 13.5 \text{ hrs}$   
 $Q_t = 50,800 \text{ cfs}$

Photo 42. San Juan Creek, type 7 design, flow conditions at confluence with Trabuco Creek during 24-hour storm hydrograph, looking upstream, prototype time 13.5 hours,  $Q_{sj}$  50,800 cfs (1,422 cu m/sec)

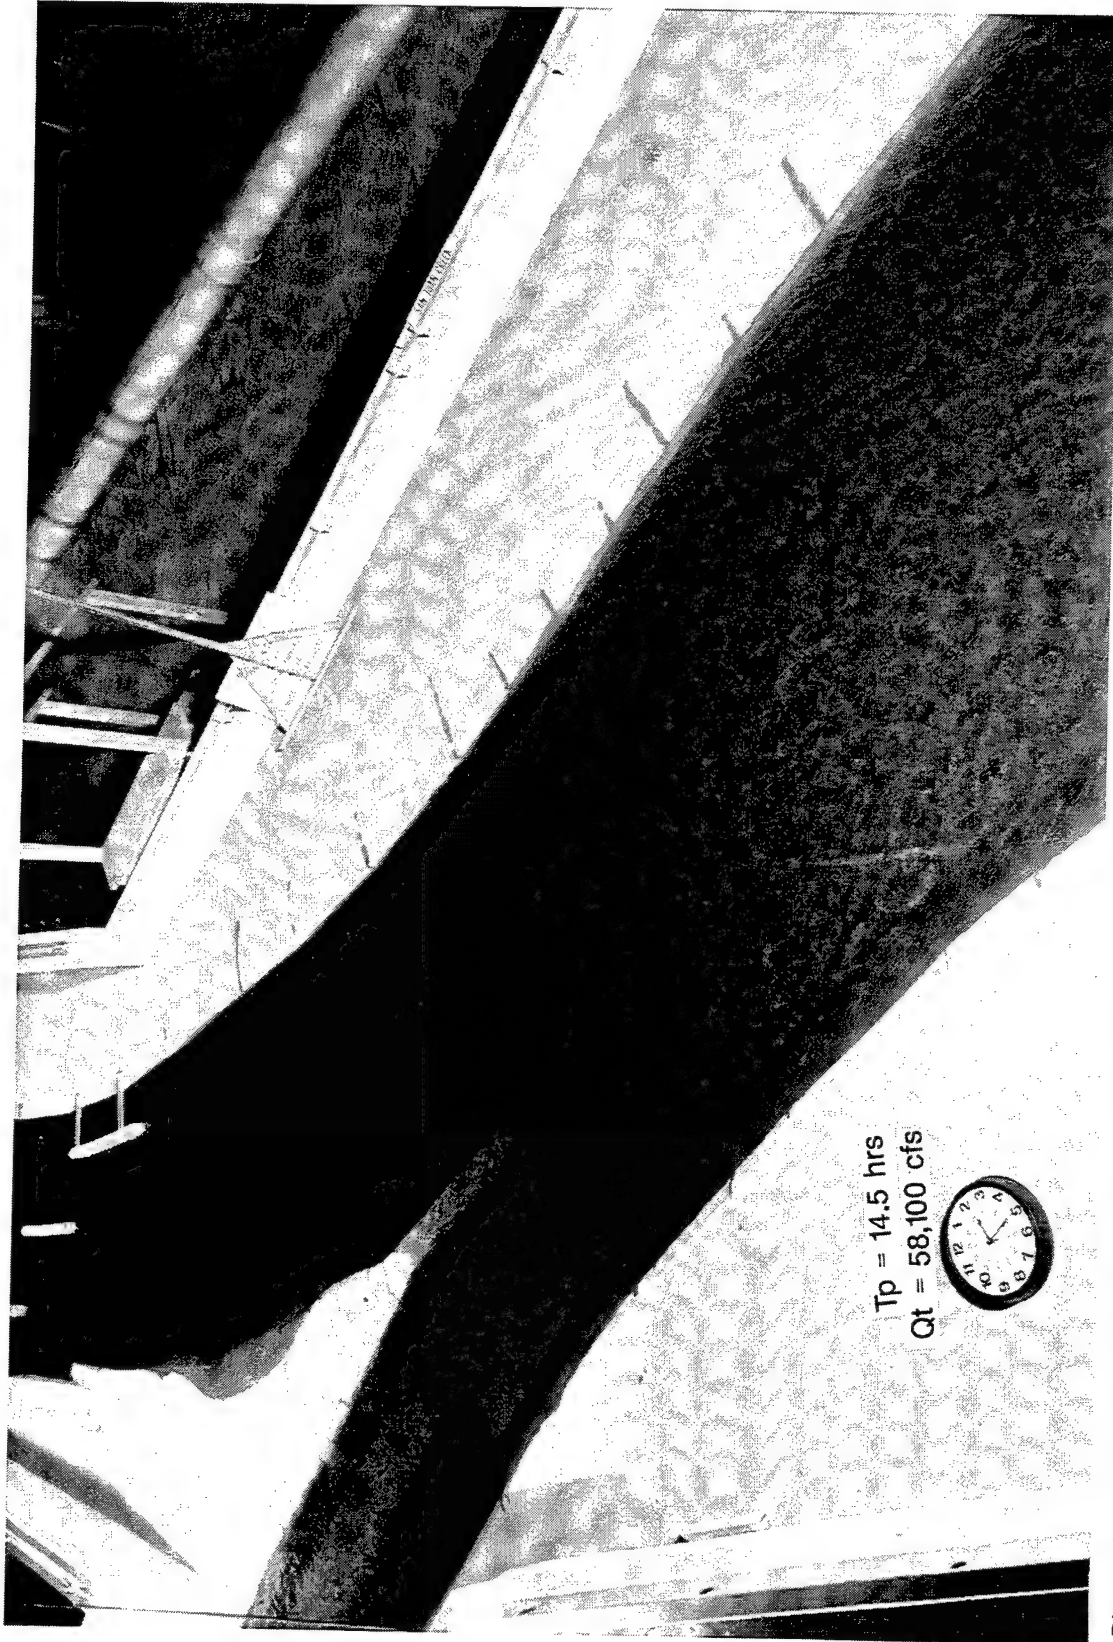
$T_p = 14.5 \text{ hrs}$   
 $Q_t = 58,100 \text{ cfs}$

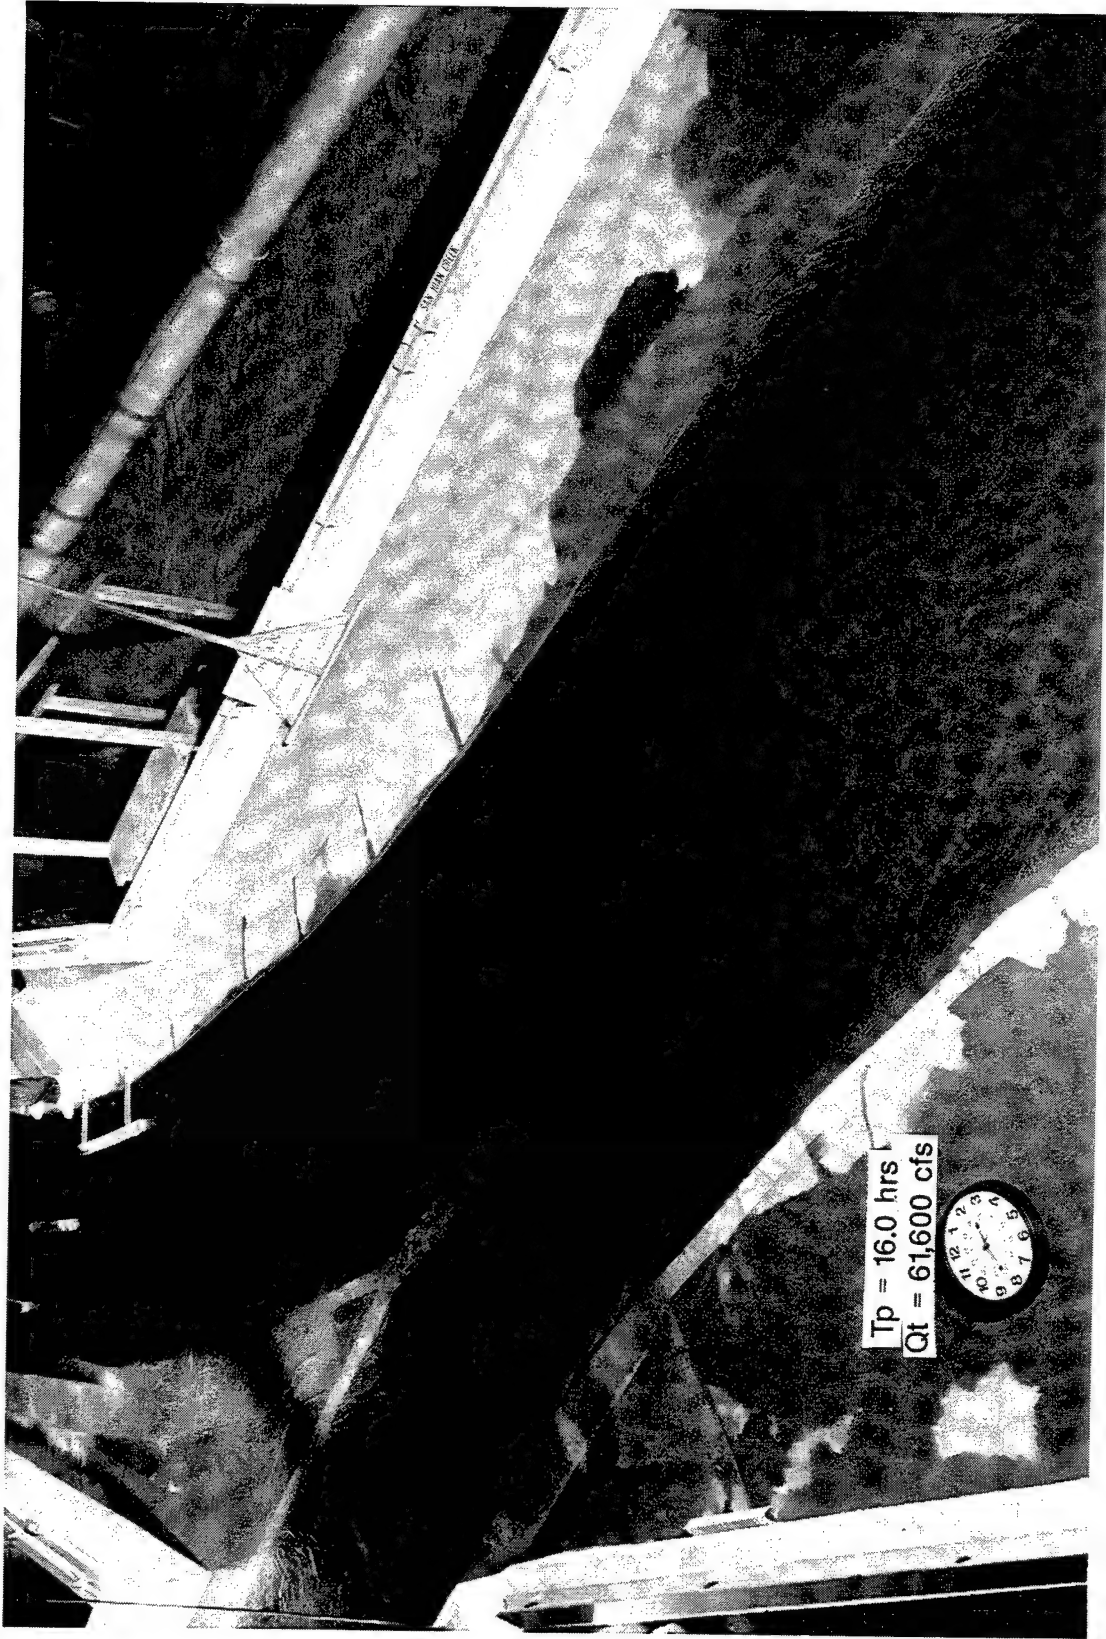
Photo 45.

San Juan Creek, type 7 design, flow conditions at confluence with Trabuco Creek during 24-hour storm hydrograph, looking upstream, prototype time 16 hours,  $Q_{sj}$  61,600 cfs (1,725 cu m/sec)

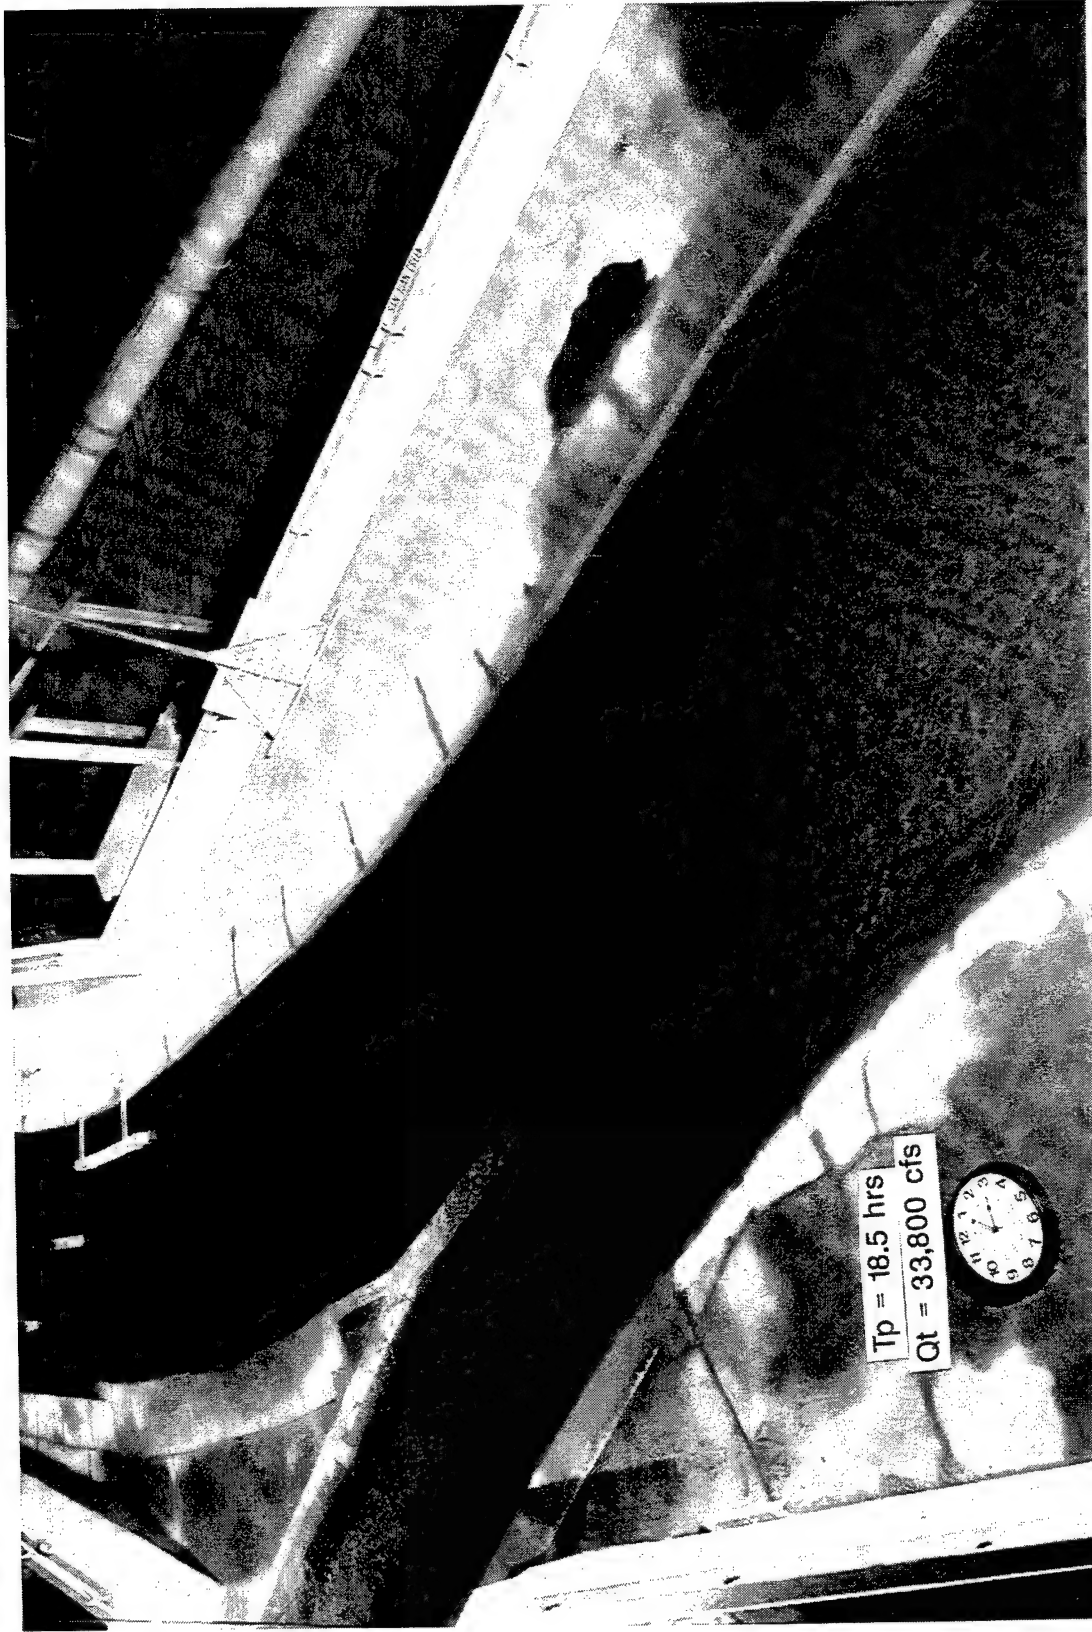
Photo 48. San Juan Creek, type 7 design, flow conditions at confluence with Trabuco Creek during 24-hour storm hydrograph, looking upstream, prototype time 18.5 hours,  $Q_{sj}$  33,800 cfs (946 cu m/sec)
